Improving Highway Information at Hazardous Locations

Seven Case Studies—Summary
of Demonstration Project No. 48

Final Report
March 1985

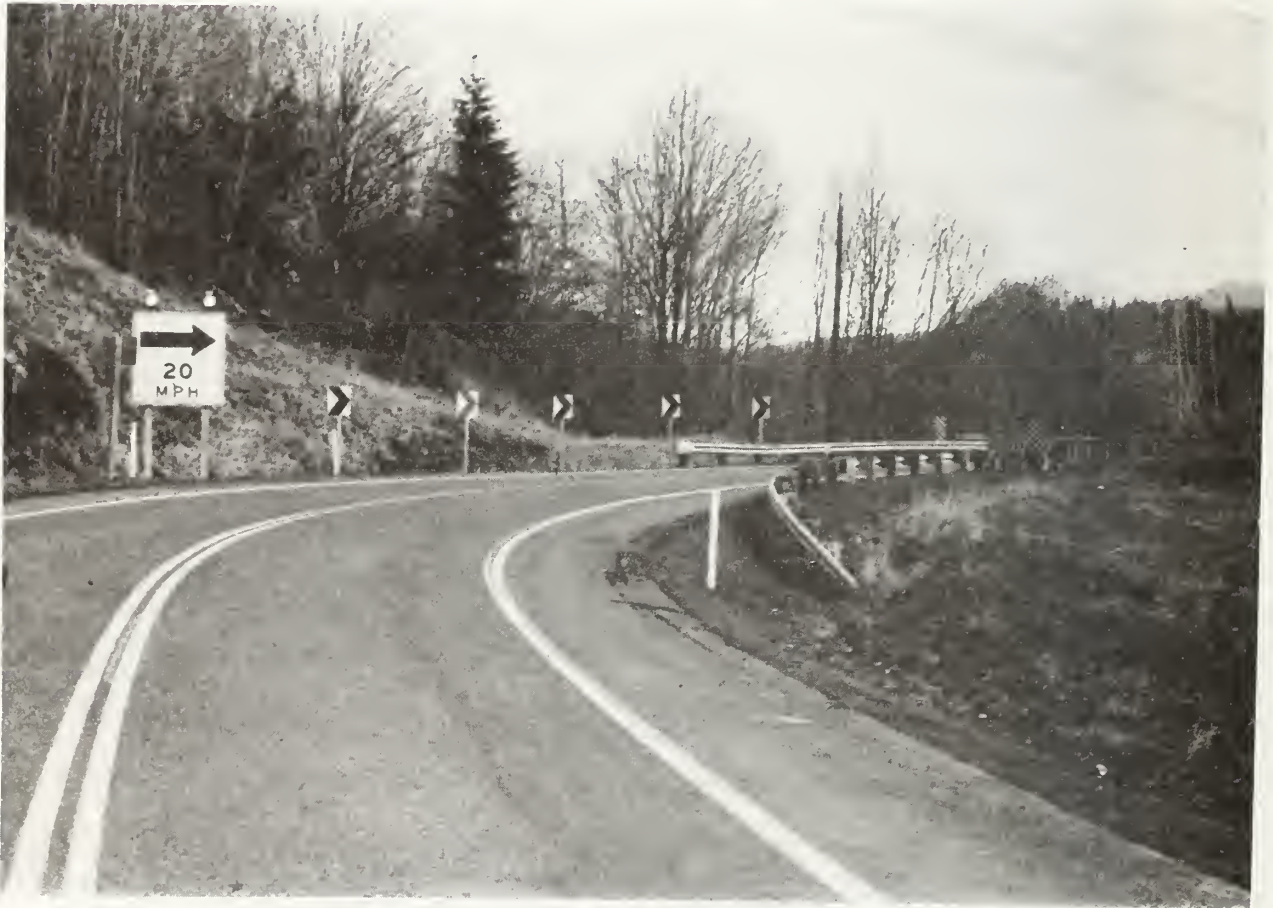
Figure 5 shows a view of the eastbound railroad bridge approach with the Positive Guidance improvement in place. The Positive Guidance plan (the plan that contains the information system improvement) that the project team generated in Function E of the 1st Edition is shown in Figure 6. In addition, the earth berm was lowered to enable drivers to see the bridge sooner. Among the features of the plan were enhanced speed control and path delineation in the bridge's approach zone. The 6-inch edge striping, in combination with double yellow center lines and Chevron Alignment signs, served to locate the compound curve bridge approach and

provided an easier path to follow. The new sequence of standard and "special" signs served to warn motorists of the approach and the bridge, and displayed needed speed and path information.

Figure 5. Eastbound Bridge Approach-Positive Guidance Improvement.

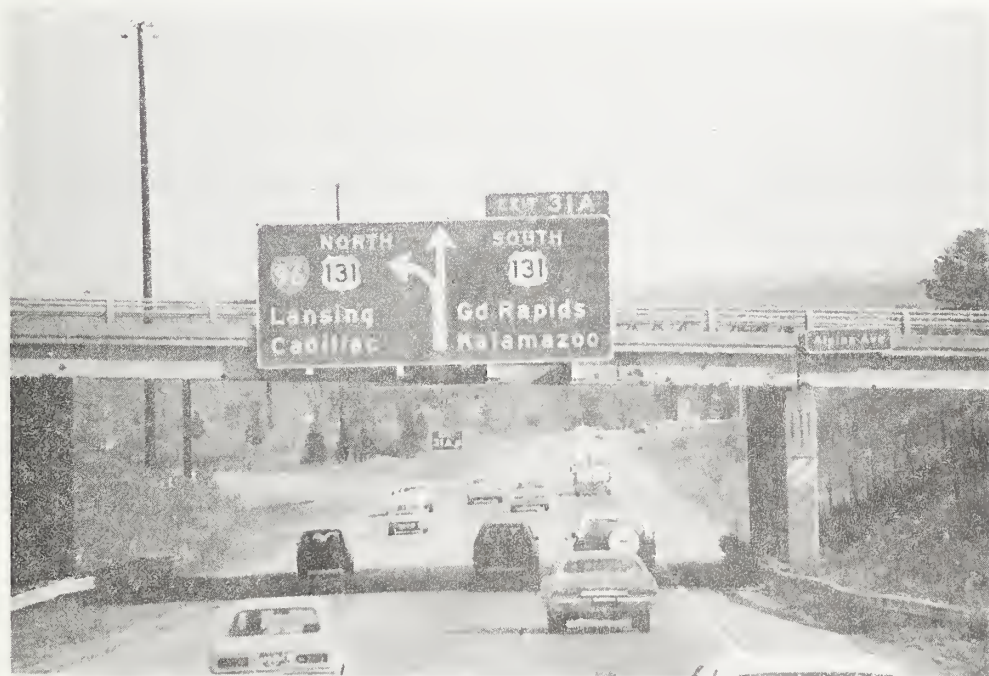
Figure 9. Diagrammatic Treatment at Split.

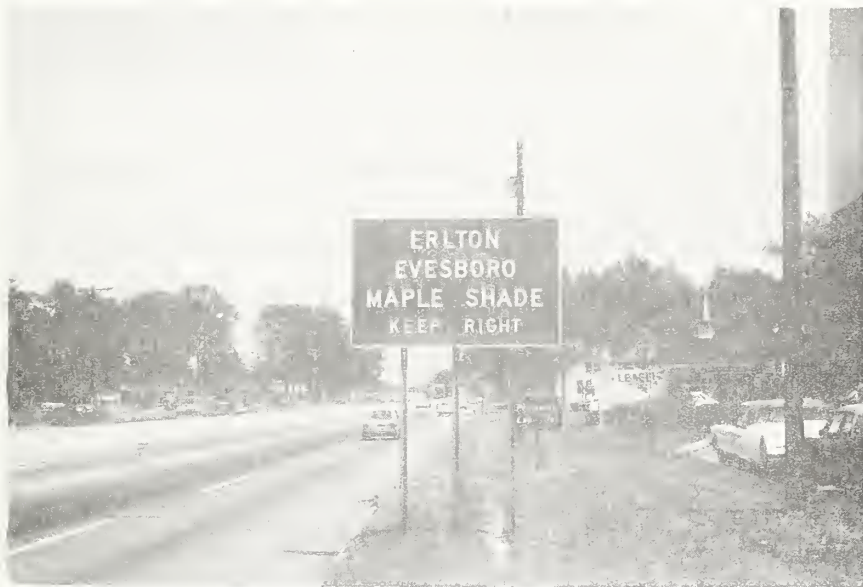
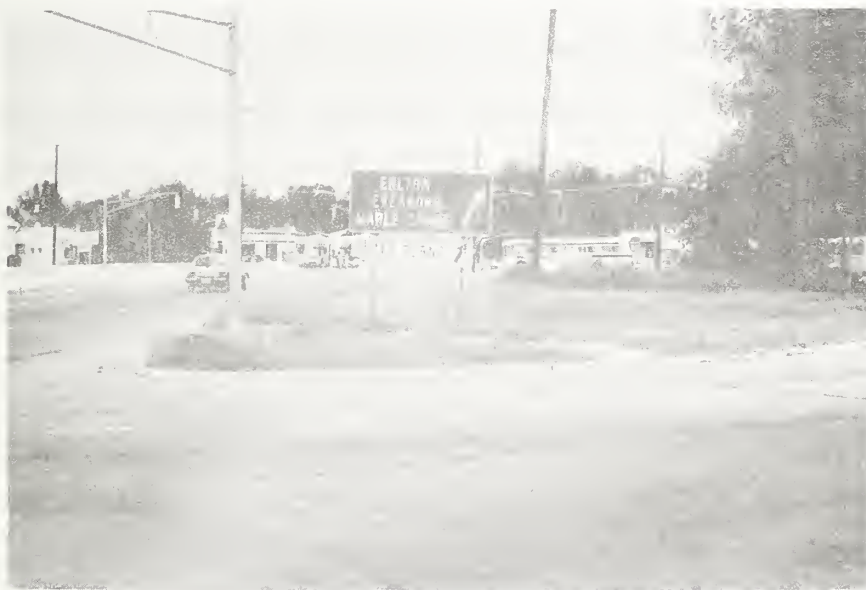
Figure 11. Navigational Information Approaching the Circle.

Figure 12. Navigational Information at the Circle.

repositioned downstream in the eastbound lane, and a stop line was added for the fire station signal (see Figure 10). Traffic signal housings were painted yellow to enhance their detectability, and 12-inch signal heads replaced the existing 8-inch units on the first set of signals in the eastbound and westbound direction on SR 38. All signing on SR 38 was improved, as were the signs at the circle and on the side streets. Continuity of route guidance and destination signing was enhanced in accordance with the Positive Guidance analysis. Figures 11 and 12 show the "After" information on the SR 38 approach to the circle.

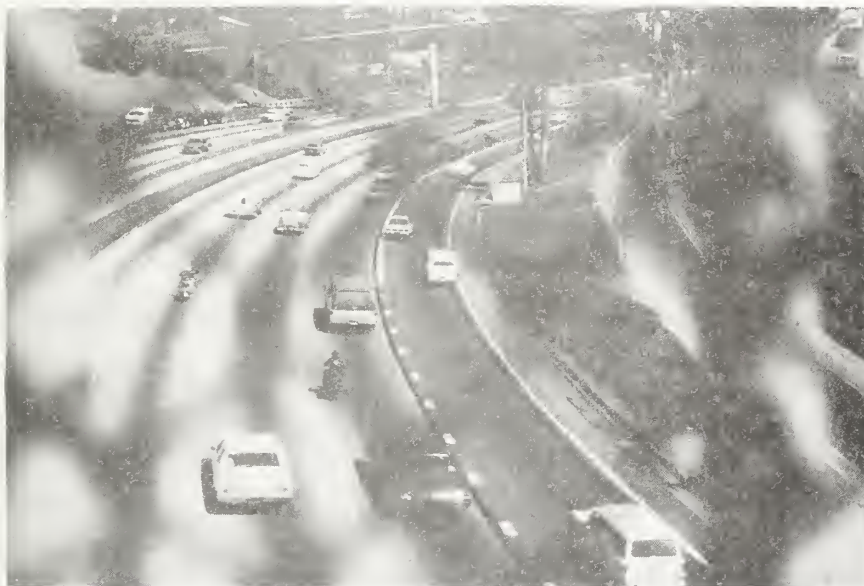
vision. Figure 14 shows the Positive Guidance information display at the lane drop. The Positive Guidance plan increased capacity, improved sight distance, and improved driver path and destination information.

Figure 14. Signing Treatment at Lane Drop.

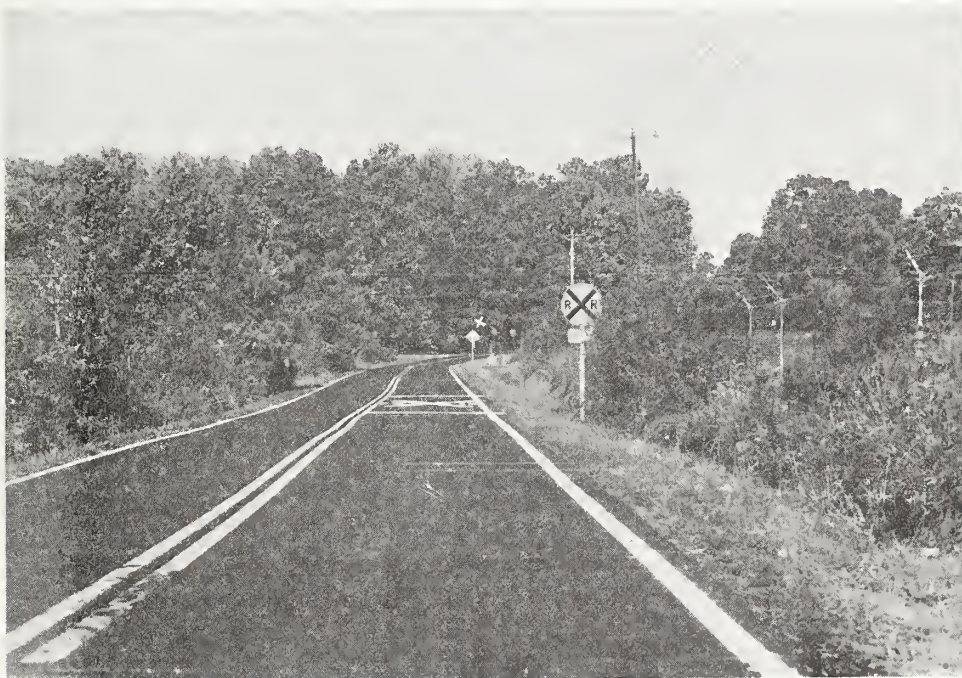
Figure 16. Eastbound View of Site.

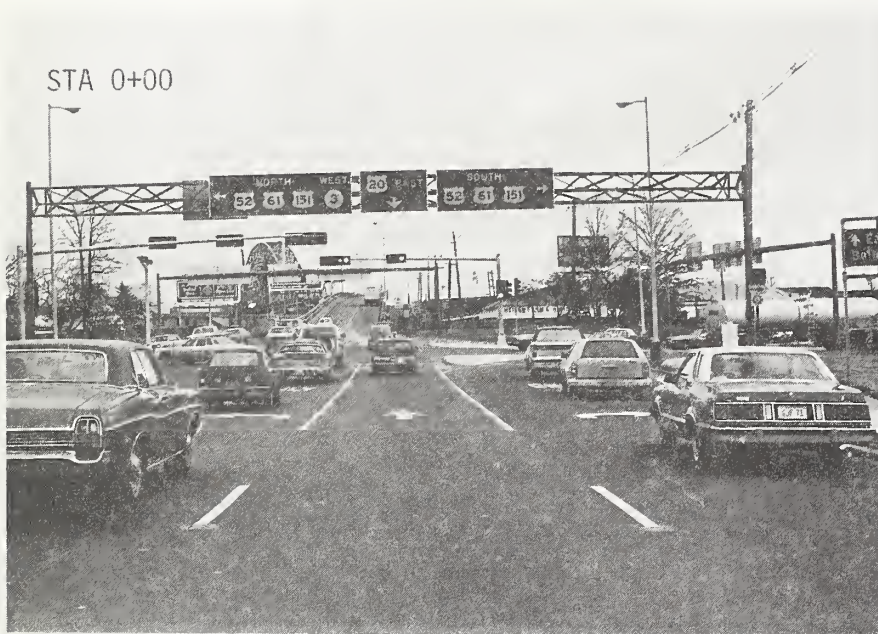
- o Dodge Street Eastbound: An enhanced routing sign was installed in the approach to Locust Street, and verification and final decision point confirmation was displayed at the intersection. Supplemental pavement markings were used for clear lane requirements. Together, the signing and markings established driver commitment and early routing identification. Signal heads over travel lanes led to quicker response. A mountable raised median barrier discouraged left turns thereby reducing midblock traffic conflicts. Finally, islands and medians provided channelization to reduce erratic maneuvers. Figure 19 shows the eastbound approach.

Figure 19. Dodge Street Eastbound.

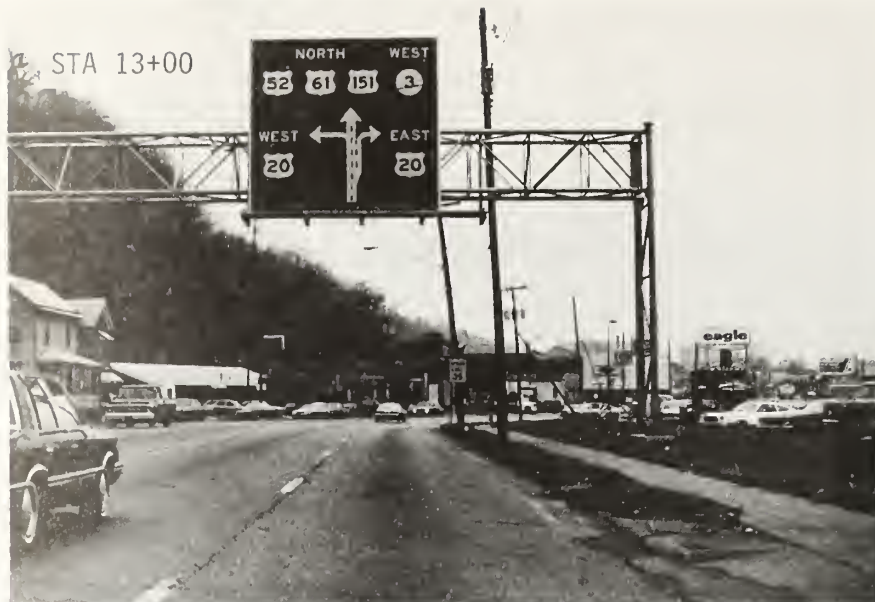
o Locust Street Northbound: An overhead diagrammatic sign displayed routing through the intersection. The existing right turn lane was extended and a road-mounted sign added to provide a "Right Turn Only" message. Overhead signs at the intersection were modified for increased visibility and lane assignment verification. Navigational information was supplemented by lane directional markings. Raised islands and center medians channelized traffic and reduced erratic maneuvers. Signal heads over traffic lanes provided increased visibility. Figure 20 shows the northbound approach.

Figure 20. Locust Street Northbound.

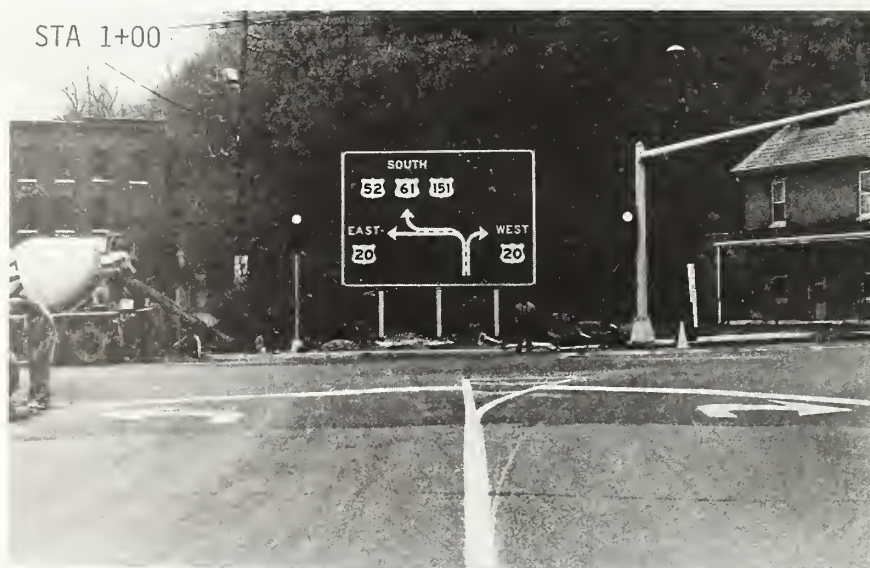
o Bluff Street Southbound: An advance roadside route marker displayed lane placement, confirmed at the intersection by a ground-mounted diagrammatic. Advance supplemental markings indicating mandatory turns for each lane yielded proper lane selection. Pedestal mounted signals were placed in the line-of-sight of the diagrammatic. Figure 21 shows the southbound approach.

Figure 21. Bluff Street Southbound.

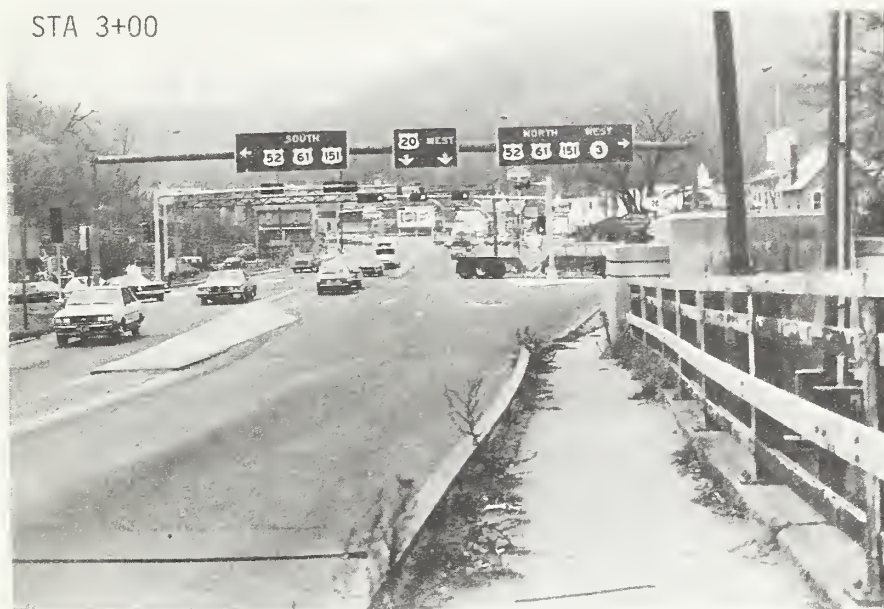
o Dodge Street Westbound: Route designation signs were realigned at the intersection, and traffic signals upgraded. A left-turn bay allowed for an additional through-traffic lane and allowed opposing left turn lanes to line-up. Raised medians and new markings delineated and channelized traffic through the intersection. Figure 22 shows the westbound approach.

Figure 22. Dodge Street Westbound.
